DELAPIDATED STORM DRAIN AND ASSOCIATED BANK EROSION ALONG WALL ST. CHANNEL

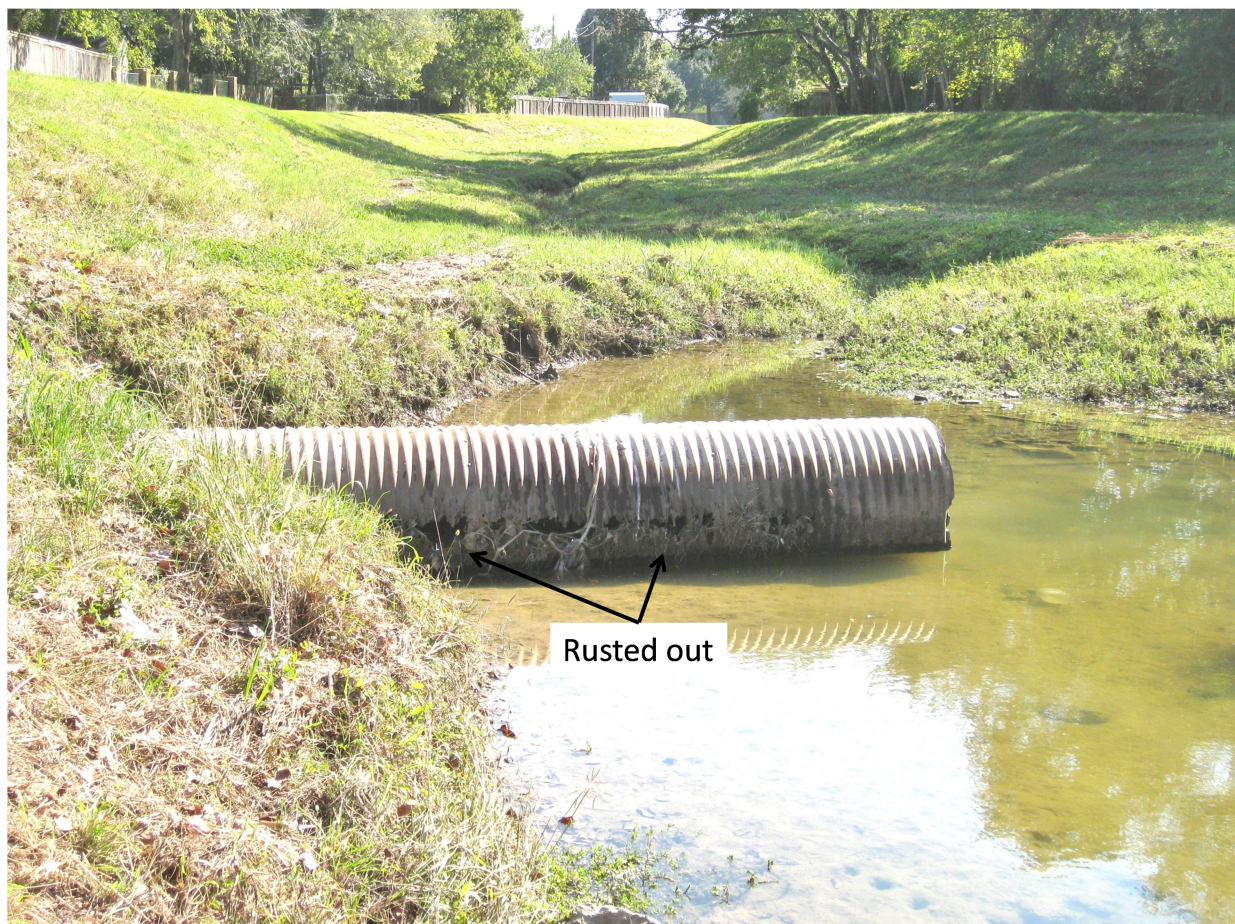
Looking east; the storm drain is rusted out along both sides.

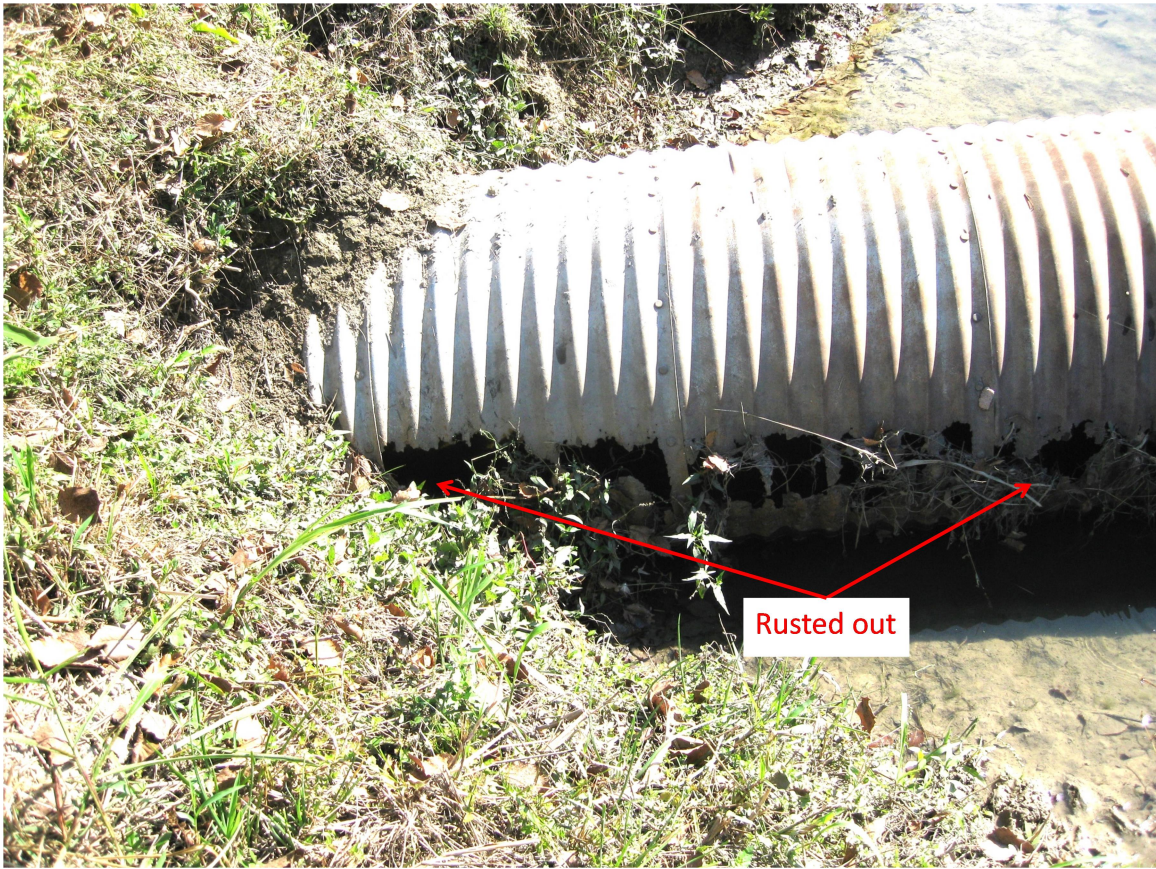
Looking east; deterioration of the storm continues beneath the bank.

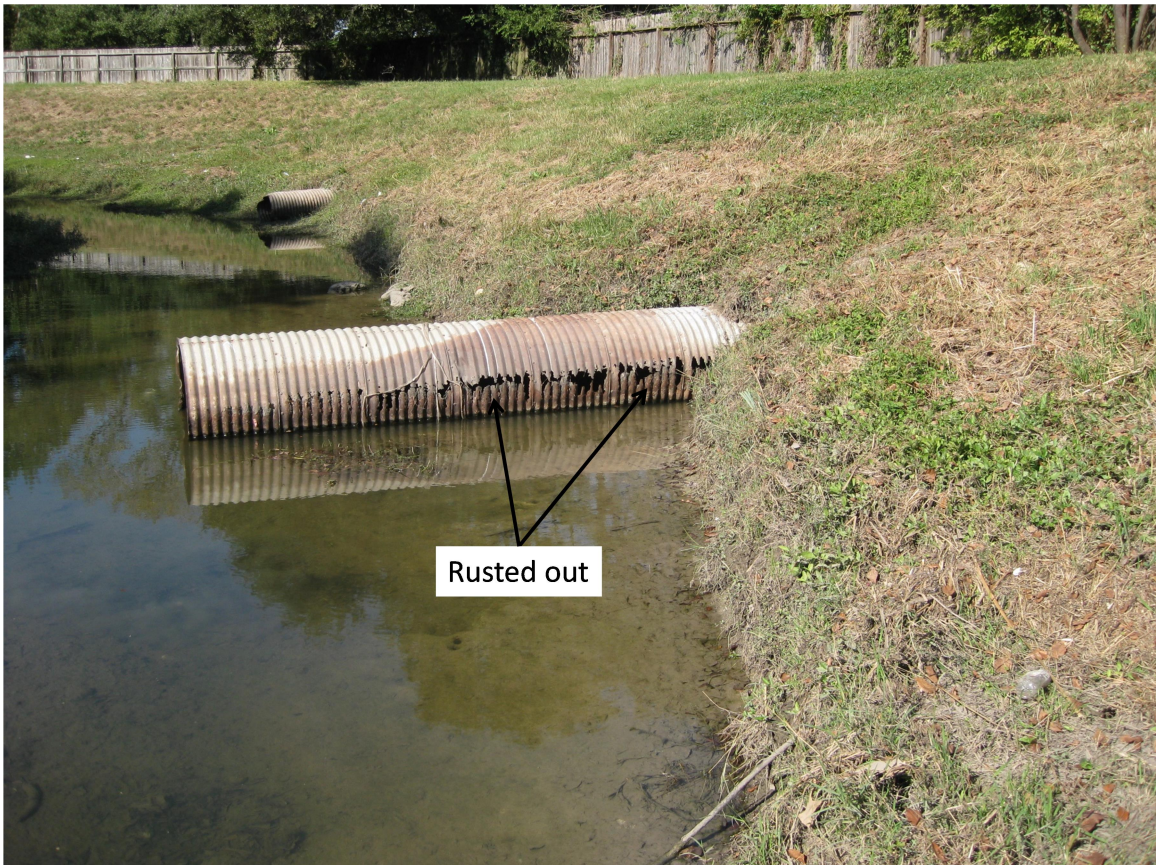
Looking west; the storm drain is rusted out along both sides.

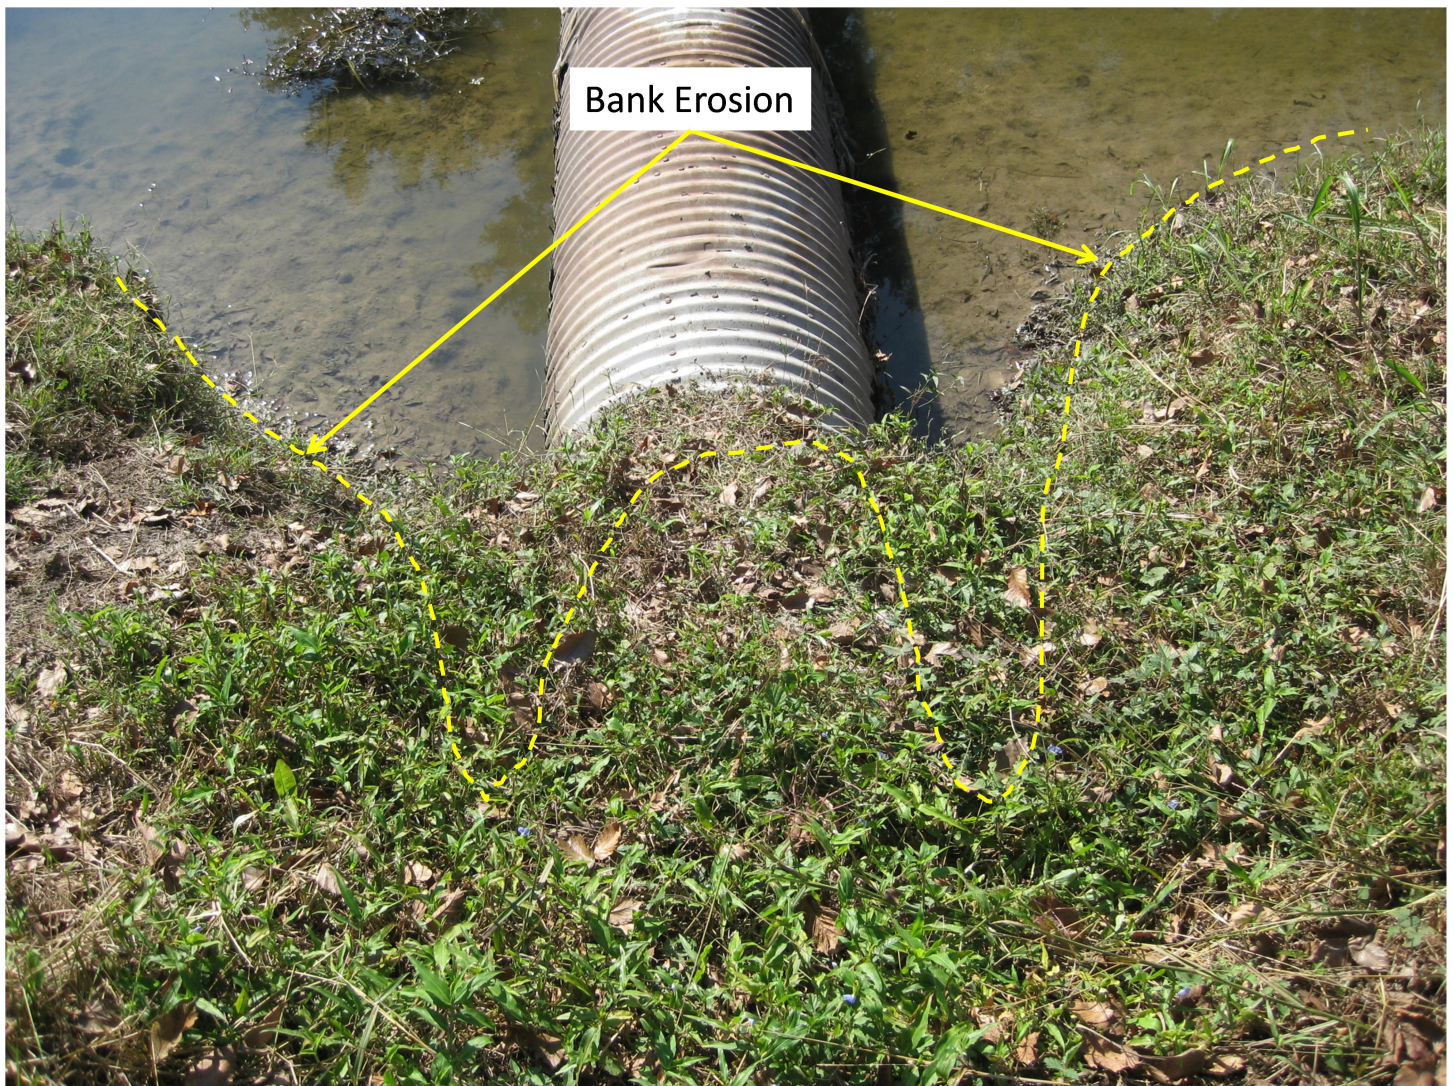
Looking south; the Wall St. channel bank has already experienced erosion. Erosion continues beneath the bank on both sides as indicated by subsidence. During high-water flow, water probably flushes out soil from beneath the bank through the rusted out sections.
