## Jersey Village City Council Meeting October 16, 2017

## Fred W. Ziehe public comments

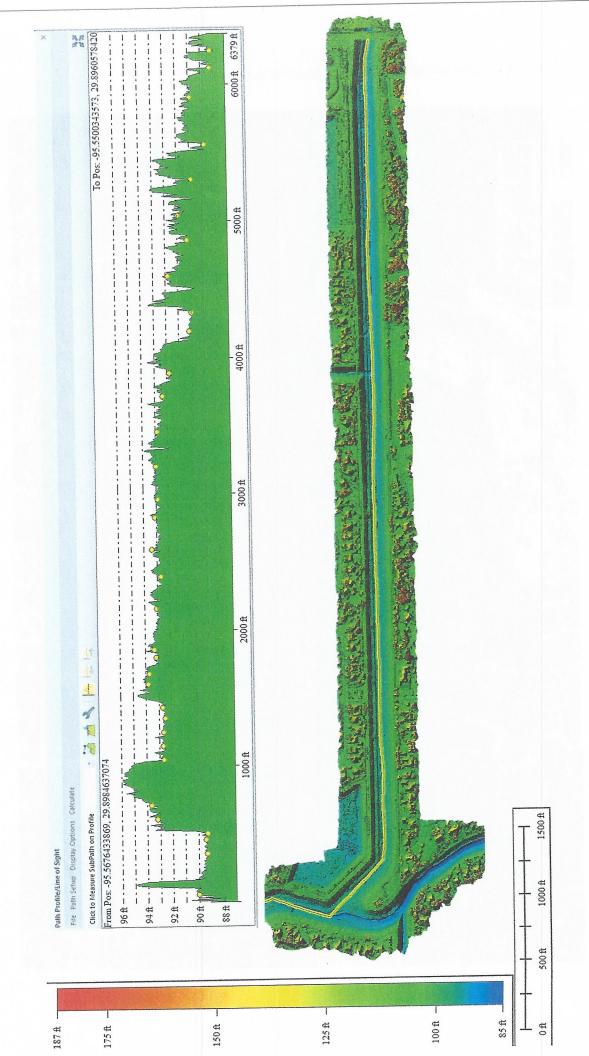
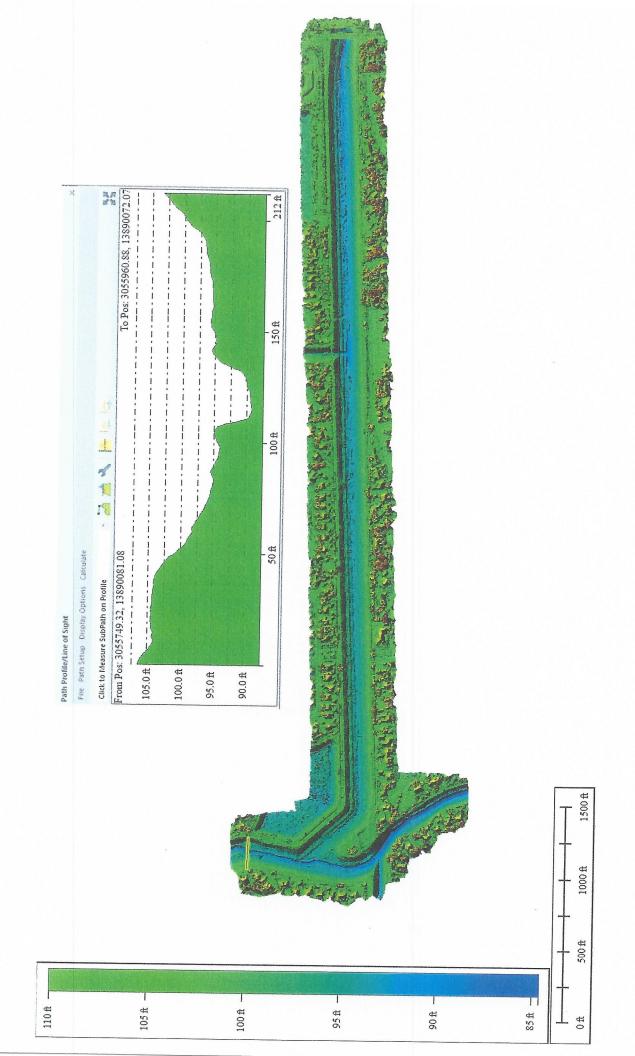
Jersey Village White Oak Bayou GCP DSM Combined 1600 DPI,pdf

This first display shows the area covered by the drone survey, which is outlined in red. The blue, green and yellow colors represent various elevation values in the By Pass. The darker blue is the deepest part of the By Pass and the green shows the higher areas. We also have cross sections and dip lines in the By Pass that specifically tell us the elevation values and show us the actual shape, or profile, of the channel.

This survey shows that the By Pass is generally flat throughout the first half of the channel and doesn't begin to dip more steeply, where water will begin to flow, until closer to the

Beltway. (This flatter profile is different than the original design of the By Pass.) The point at which the water actually begins to move downstream is referred to as the "Spill Point". On the display, this is where the darker blue colors begin.

This flat portion causes the water to simply pond in the first half of the channel and won't begin to flow down the By Pass until it gets to the Spill Point. As that water ponds, it will also likely prevent or slow down water trying to enter the By Pass.....and therefore causes more water to stay in the JV Main Channel.....which is exactly what we have witnessed.

Also, the entrance to the By Pass is ~ 4 feet higher than the Main Channel. As a result, water from the Main Channel WILL NOT even enter the By Pass until the water level exceeds this 4 feet. And then, water will not actually flow until it reaches the "Spill Point", nearly 2/3s of the way down the By Pass.

We suspect that some of the flattening in the By Pass is due to sediment collecting in the channel since it was originally built in 2010. Initially, it may have had a steeper grade from west to east, but over time, it's gotten flatter. THIS SEDIMENT NEEDS TO BE REMOVED SO MORE WATER WILL FLOW INTO AND DOWN THE BY PASS DURING THE EARLIER TIMES OF THE RAIN EVENT. In addition, the slope on the front end of the By Pass needs to be made steeper to move the spill point further to the west so water will flow sooner and not collect in the channel.
