November 10, 2016

**RE: Preliminary Environmental Investigation
 City of Jersey Village Long-term Flood Recovery Plan
 City of Jersey Village, Harris County, Texas**

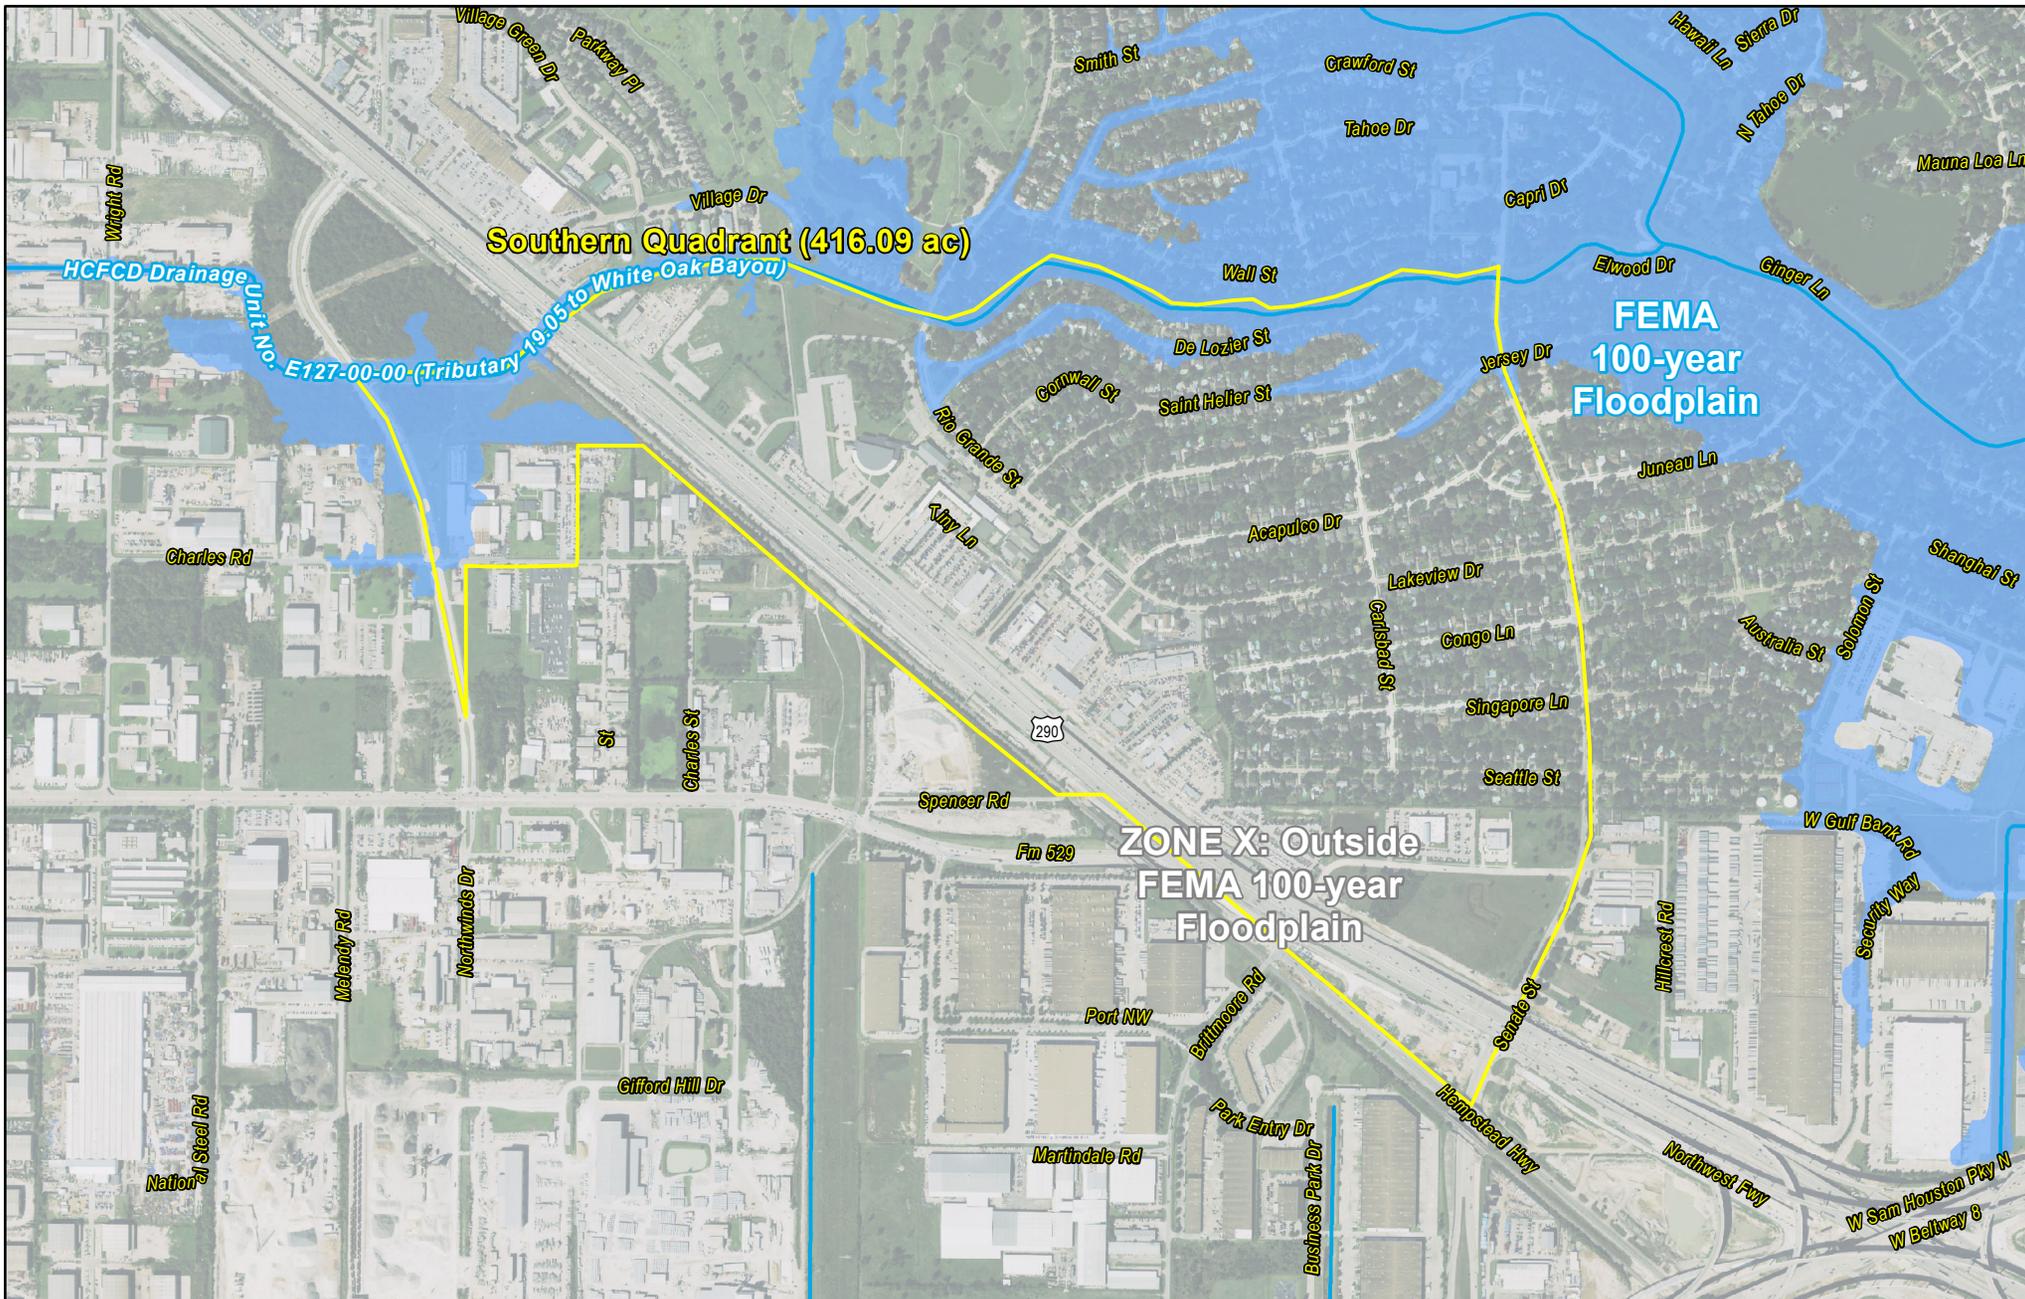
2014 AERIAL PHOTOGRAPH WITH
 FEMA FLOODPLAIN DATA

**FEMA
100-year
Floodplain**

The Federal Emergency Management Agency (FEMA) floodplain maps (Panel Number 48201C0440M, effective June 9, 2014) were examined to determine if the subject property is within the 100-year floodplain. Of the total western quadrant area, 8.5 percent is located within the 100-year floodplain. A **2014 Aerial Photograph with FEMA Floodplain Data** is included in **Attachment A**.
